# Joint Network Secretariat Normal Procedure Task Force **Broken wheels**

Brussels, 28. November 2019

**Final output**

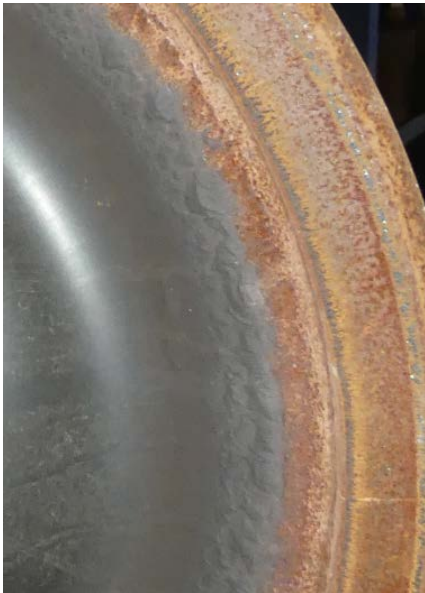
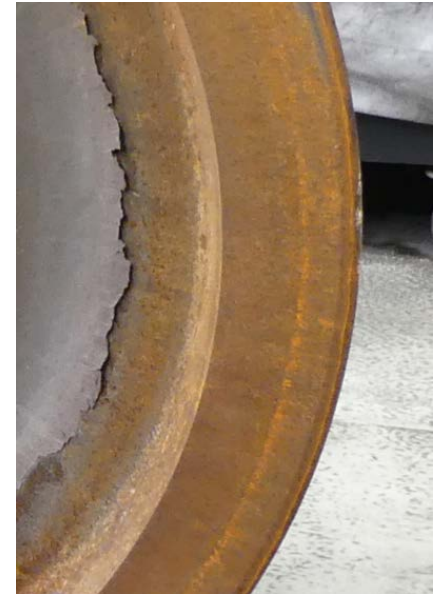
Paint shall be clearly burnt => paint in this area shall present cracks/ peeling / bubbles (no direct dispersion)

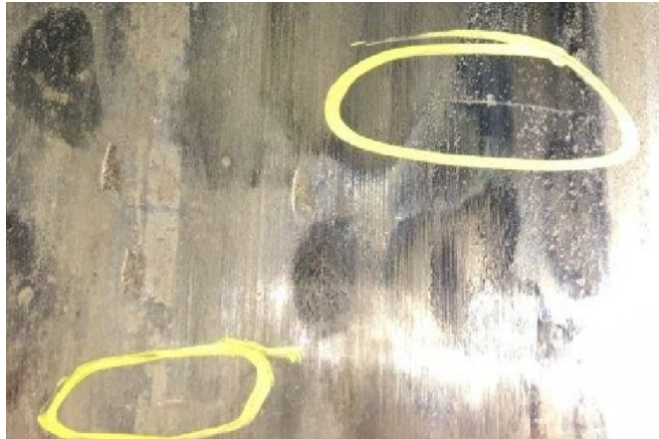
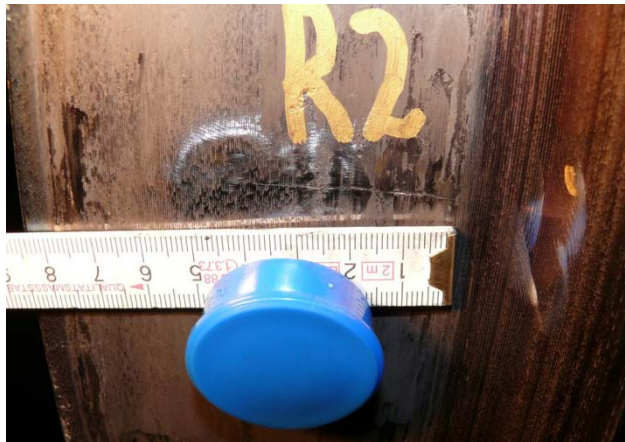
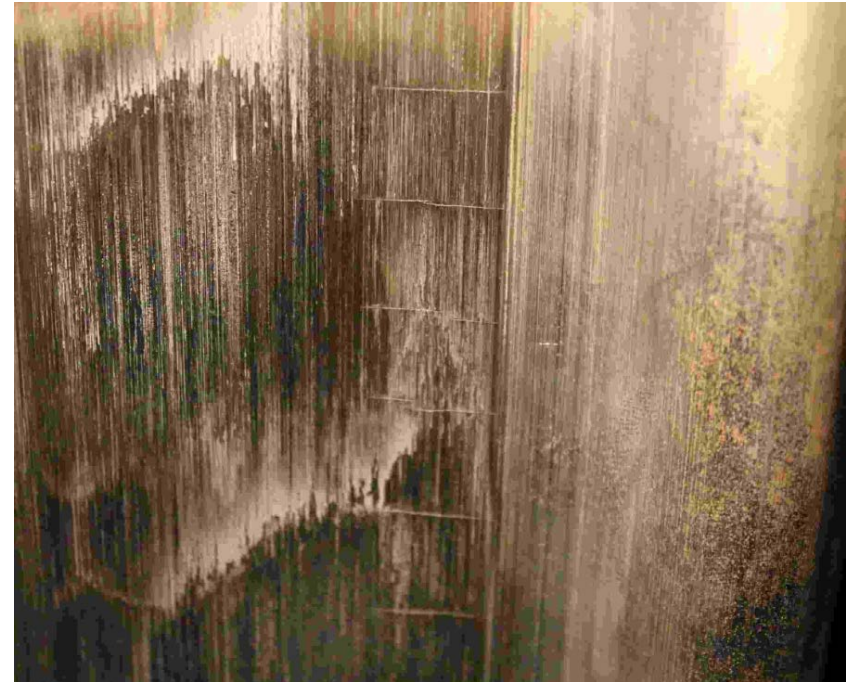
Example for single cracks on the wheel tread by visual inspection

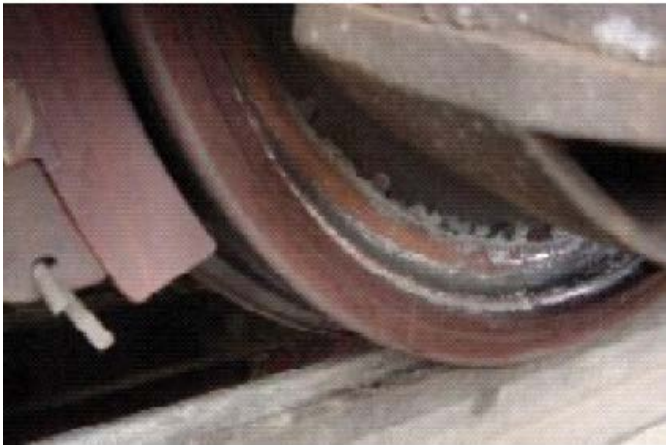
**Description:** This type of defect occurs only in tread-braked wheels. When suitable coatings are used, the paint becomes clearly burnt in the rib/web transition radius when the temperature exceeds approximately 300 °C. The paint in this area then becomes cracked and peeling. The brake blocks are often melted to some extent. Build-up of metal and characteristic colouring can be seen on the tread. The rim may also become a bluish colour.

If the problem is not detected immediately the rim/web transition can gradually assume a rusty appearance with shades between greyish-brown and brown covering the whole circumference. [EN 15313, §C.3.2.2 ]

Overheating affecting the wheel rim/web transition [EN 15313, §C.3.2.2 ]

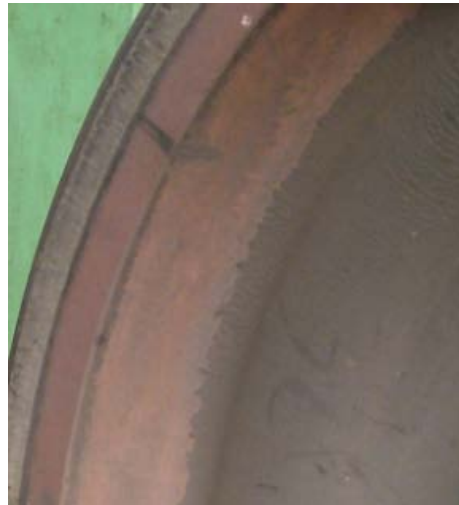
Old and fresh burnt paint

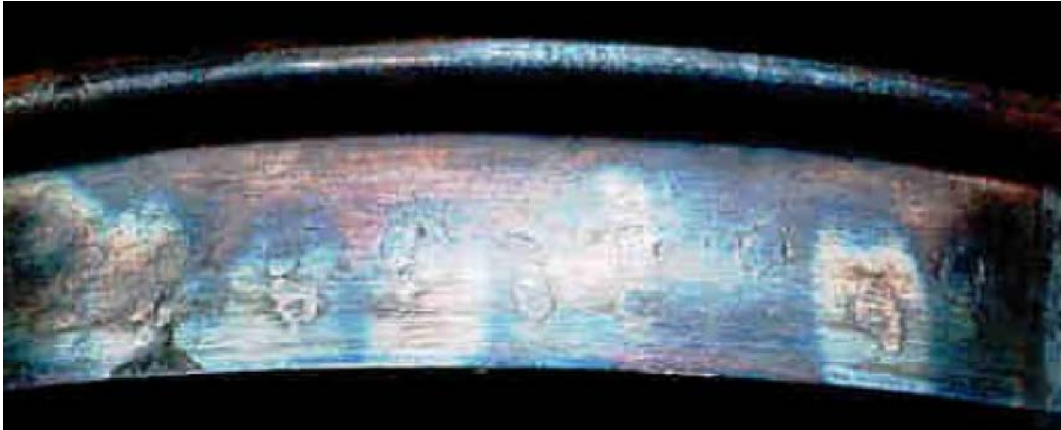
colouring on the tread

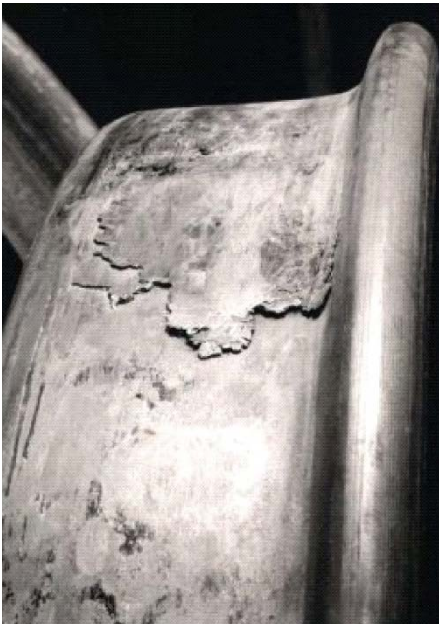
Metal build up on  
the tread

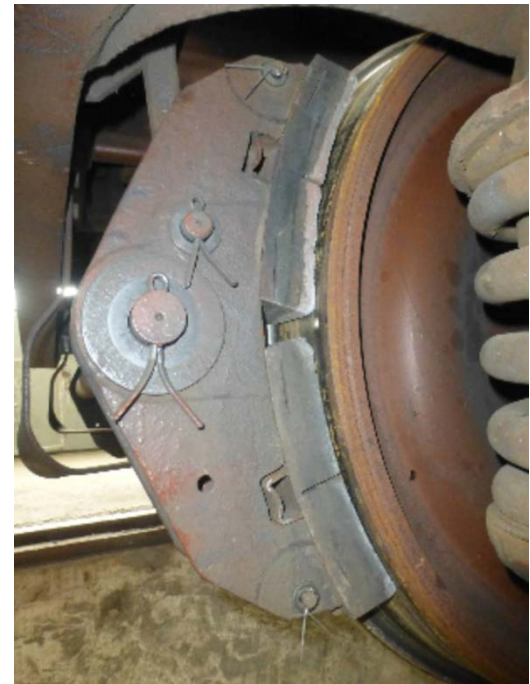
Melted brake block

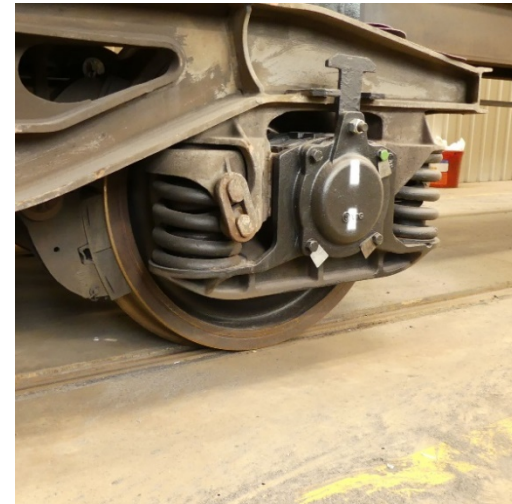
- The test on the 12 o'clock position (upper position of the wheel) sounds always thud/ damped.
- Wheelsets with applied brake blocks or not fully released brake blocks sound also thud/ damped. In this case the full release of the brake blocks has to be checked.
- In case of a thud / damped sounding wheel it is necessary to inspect the whole wheel more carefully.

Hammer/ sound test can be adapted in special cases as additional method to detect cracked rim/ broken wheels.
